# ELEANOR PEW MORRIS MEMORIAL ARENA FEASIBILITY STUDY

Draft Report – July 12, 2024

Prepared for: Church Memorial Park Board of Trustees

DSRA Architecture Inc.

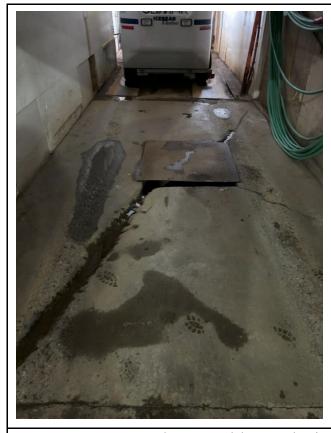
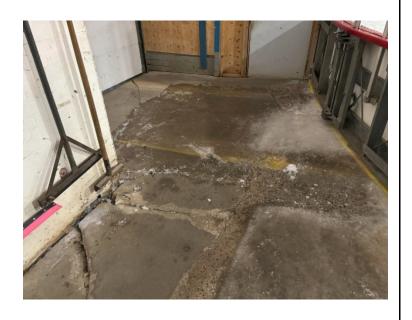
adequate concrete repair procedures.

Damaged concrete slab at Zamboni ramp & Damaged concrete slab at Zamboni addition

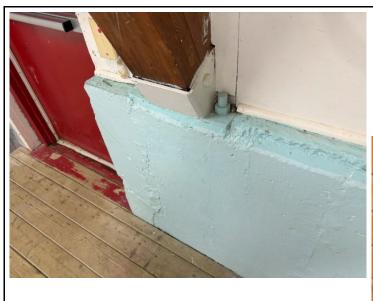
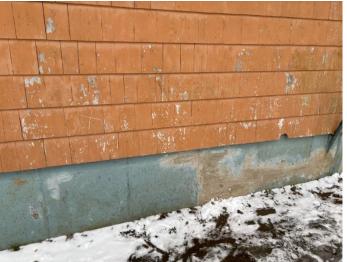
Patched concrete foundation wall on hockey rink exterior & Concrete foundation wall on curling rink interior

Continue to repair any deteriorated concrete in the foundation walls or piers as required. Additional concrete testing to determine service life and durability should be done in order to extend service life beyond 65 years.

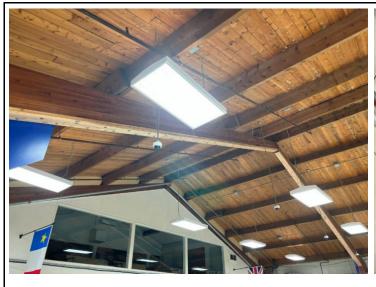
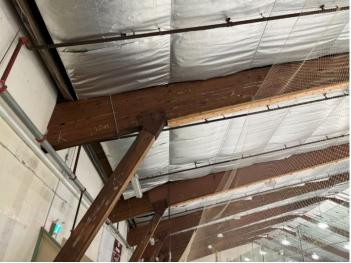
The hockey arena and curling rink structure is in excellent hands and additional reinforcing should be completed to provide adequate overdesign for future environmental loads. The steel side plates and U-brackets that were installed in the past should definitely be removed as per WRD recommendations and as long as deterioration due to the steel in contact with the wood is not significant the structure should be able to serve many more years.

Glulam rafter with completed reinforcing in curling rink & Glulam rafter with completed reinforcing in hockey arena

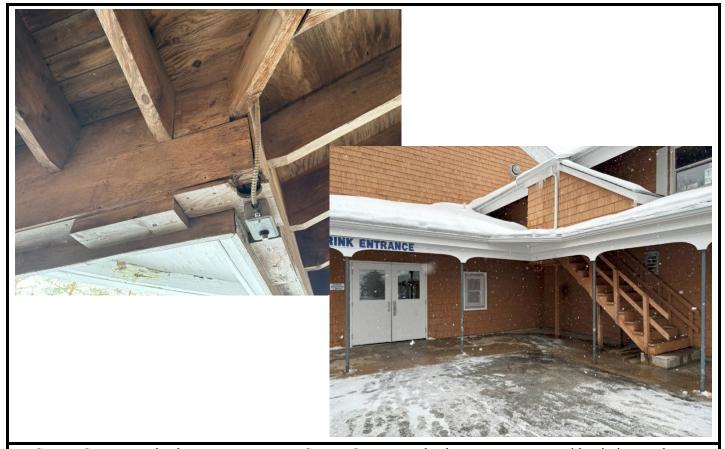
Canopy Structure at hockey arena entrance + Canopy Structure at hockey arena entrance with missing steel post

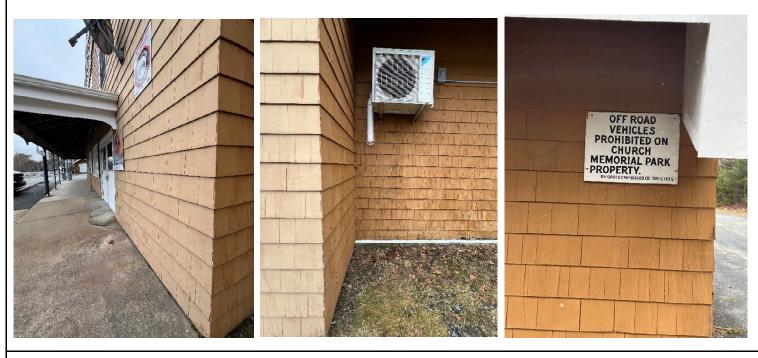
**Typical Wood Cladding Condition**

**Recommendations:** The wood cladding should be replaced in 2025.

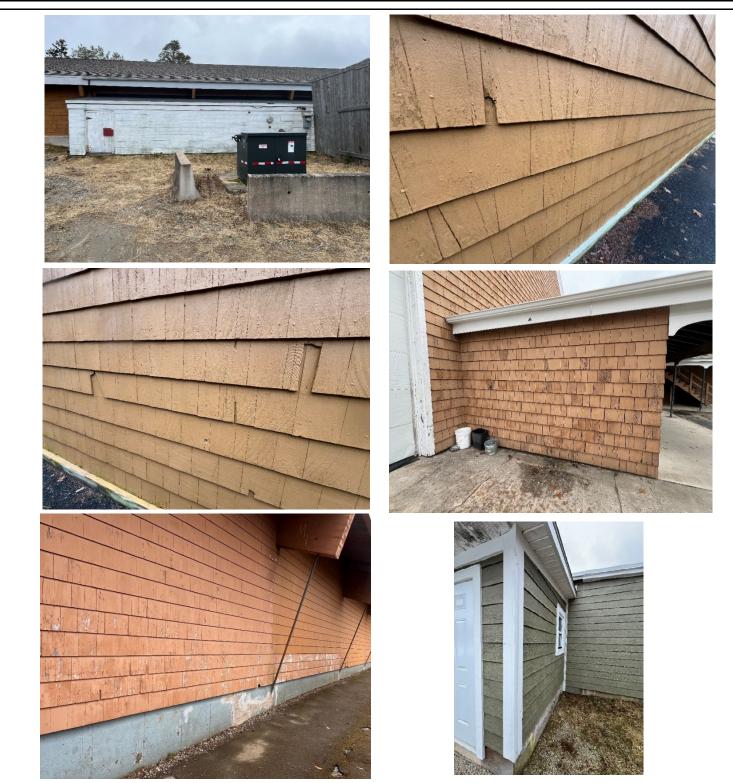
Chipping and Discoloration of Wood Cladding

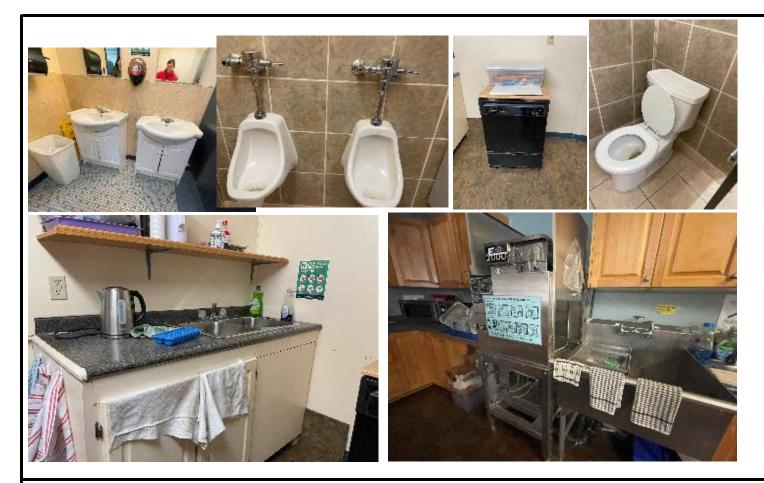
Various plumbing fixtures observed during Feb. 02 site visit.

**Recommendations:** Plan for replacement of fixtures over the next 5-10 years.

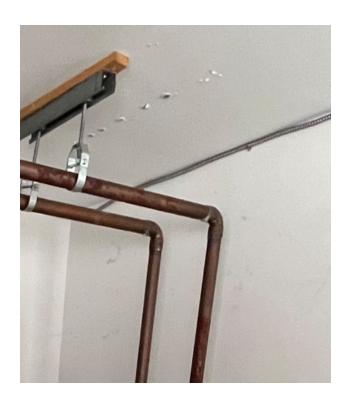
Copper Domestic Water Piping

**Recommendations:** Plan for replacment of all domestic water plumbing piping.

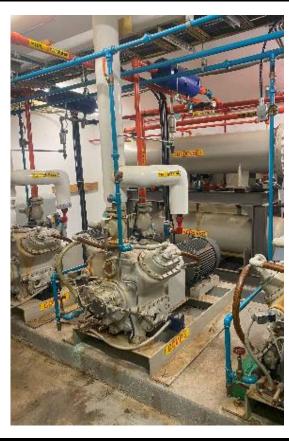
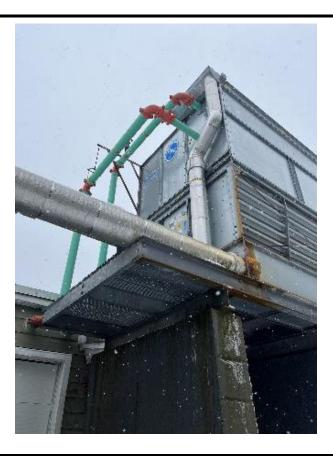
(Left) Portion of hockey rink ice plant. (Right) Cooling tower on raised platform outside of hockey rink

**Recommendations:** Plan for replacement in 15 years.

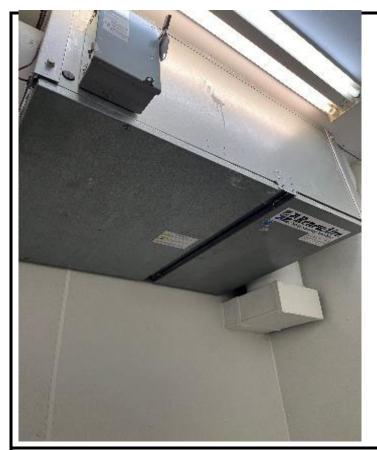
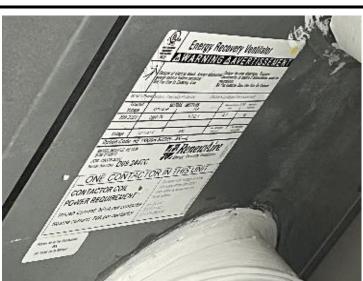
Energy recovery ventilator located outside locker room for hockey rink

**Recommendations:** None at this time. Plan to replace in 5-10 years.

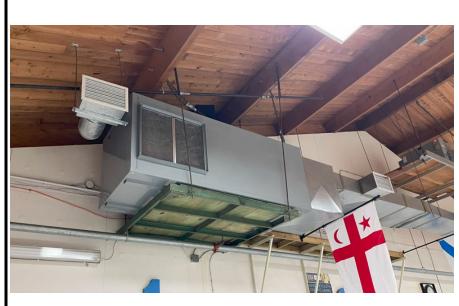
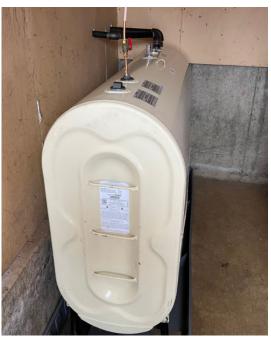
(left) Oil furnace located on raised platform above curling rink and (right) oil tank.

**Recommendations:** None at this time.

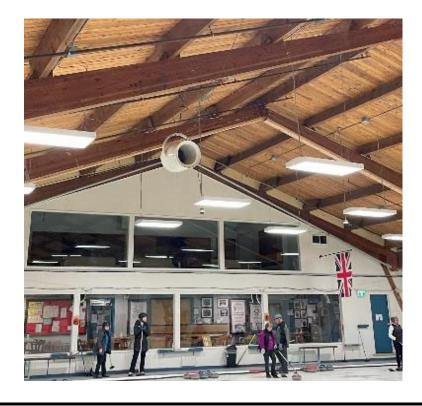
Fan located above curling rink ice surface

**Recommendations:** None at this time.

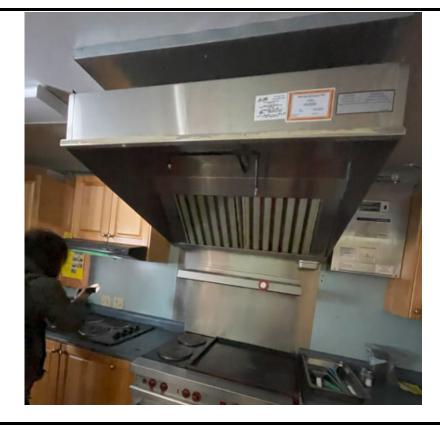
Commerical Kitchen Hood

**Recommendations:** The age of the system is unknown but plan for replacement in the next 10 years.

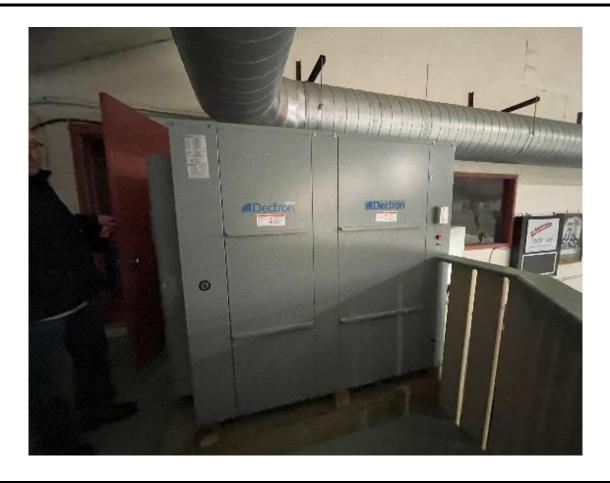
Dehumidifier unit serving hockey rink

**Recommendations:** Plan for replacment in 5 years.

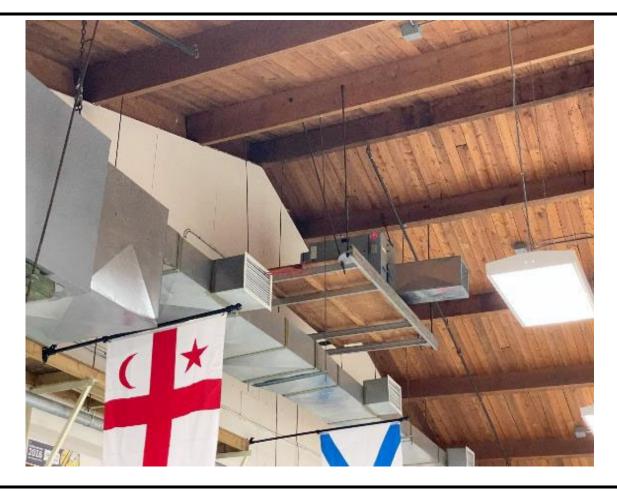
Dehumidifier unit located on platform above curling rink

Plan for its replacement in 5 years.
