# ELEANOR PEW MORRIS MEMORIAL ARENA FEASIBILITY STUDY

Draft Report – July 12, 2024

Prepared for: Church Memorial Park Board of Trustees

DSRA Architecture Inc.

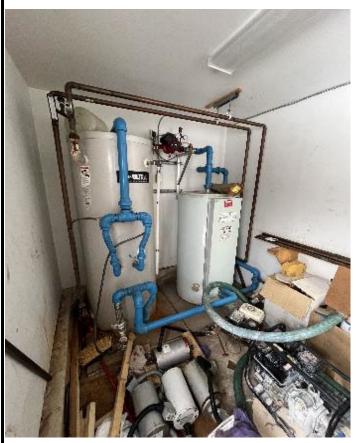
service life.

(Left) Two hot water tanks preheated from a heat pump. (Centre) Propane booster water heater. (Right): Heat Pump

**Recommendations:** Plan to replace two of the water heaters in the next 5 years.

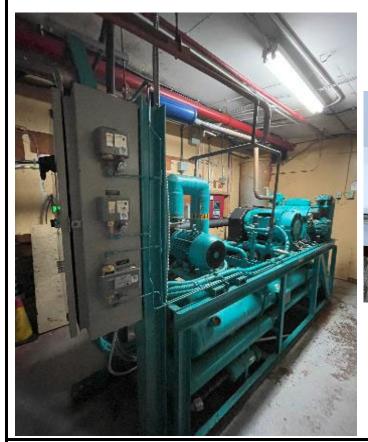
(Left) Curling rink ice plant. (Right) Dry cooler on roof outside curling rink

**Recommendations:** Plan for replacement with a new plant incorporating heat recovery to heat curling rink change rooms

and lounge. Replace by 2032 with system incorporating more modern refrigerant.

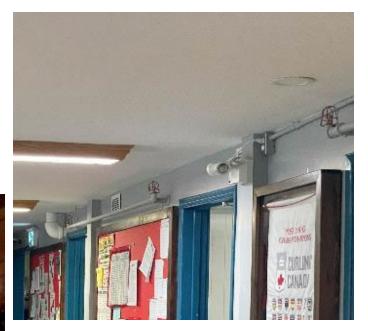
(Top Left) Dry sprinklers serving curling rink. (Bottom Left) Sprinkler tanks and associated piping. (Right) Wet sprinklers serving curling rink observation area.

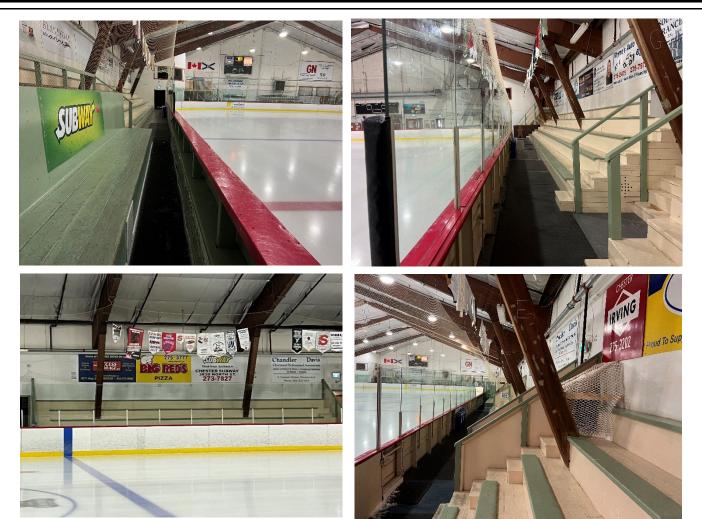
Bleachers

Condition and Anticipated Replacement:

The condition of the arena bleachers is fair. Most concerns are aesthetic.

**Recommendations:** The bleachers are not in bad shape, just have aesthetic damages that could be refurbished. However,

the bleachers are an older, outdated style, it is recommended that they are replaced with a newer

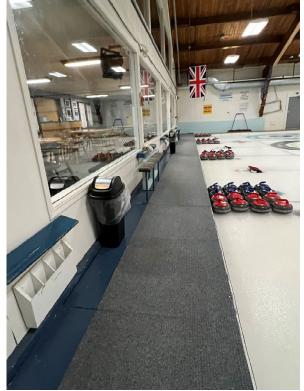
**Curling Rink**

**Observations:** Minor scratches and other wear and tear can be seen on the surrounding Ice Rink Dasher Boards.

The system was replaced 10 years ago and in good conditiion.

The Ice pad is in good condition. The Ice Rink Dasher Boards are in fair condition.

**Recommendations:** It is recommended to upgrade the Ice Rink Dasher Boards of the Skating Rink in the next 20 years.
